# Manhole Inspection Summary

Manhole # S13GG\_042MH

Insp Date: **2/23/09 1:50 PM**

**Location** Address: **1635 PRESBURY**

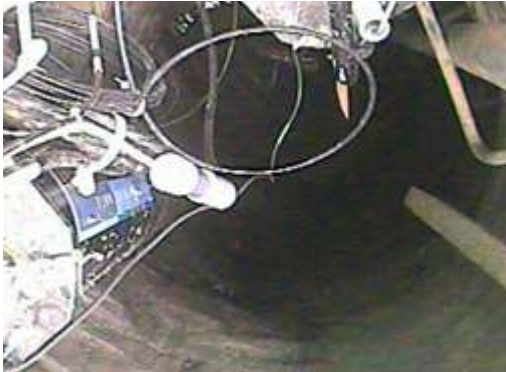
meter in the MH

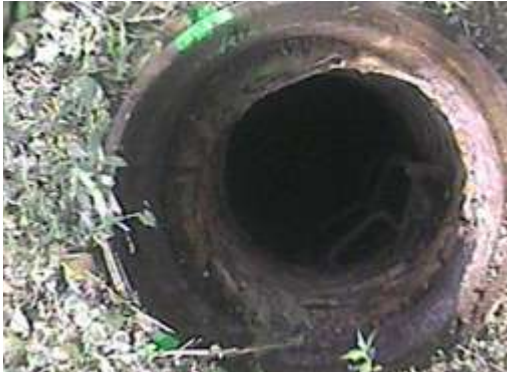
Defect 1

☒ **Evidence Of Surcharge**

Depth: **8** (ft.) ☐ Active Surcharge Present

evidence of ASUR

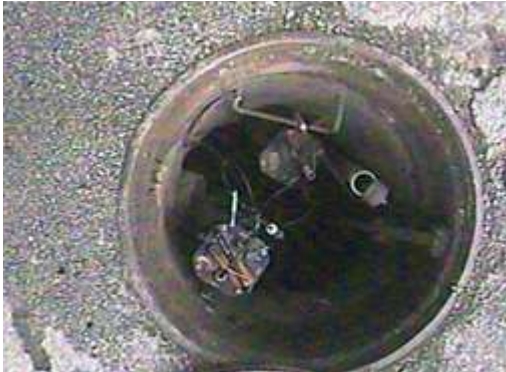
Defect 2

Offset: **4** (in.)

frame offset

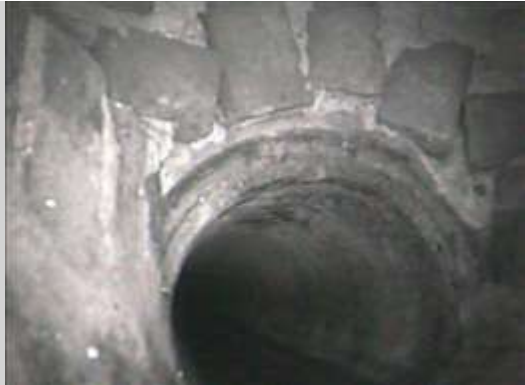
12 O'Clock Outflow

27 in. Circular Gravity Sewer  
Pipe Out @ 12 O'Clock

Pipe Material: **Clay** ☐ Pipe Lined

Invert Depth: **18.47** (ft.) Flow Characteristics: **Turbulent**

Infiltration: **None** Pipe Seal Cond: **Unknown**

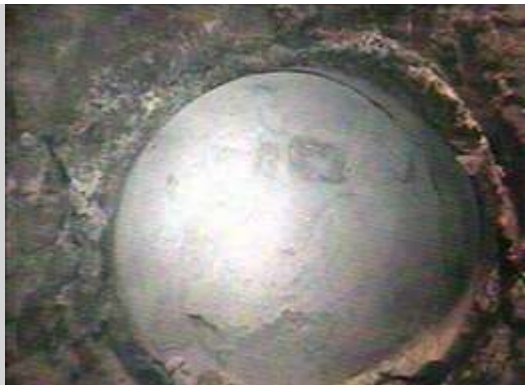
2 O'Clock Inflow

21 in. Circular Gravity Sewer  
Pipe In @ 2 O'Clock

Pipe Material: **Clay** ☐ Pipe Lined

Invert Depth: **10.24** (ft.) Flow Characteristics: **None**

Connects To: **Stub connection / abandoned**

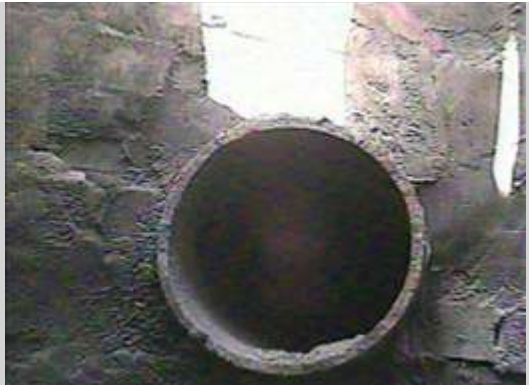
5 O'Clock Inflow

8 in. Circular Gravity Sewer

Pipe Material: **Clay** ☐ Pipe Lined

Invert Depth: **2.98** (ft.) Flow Characteristics: **None**

Connects To: **House connection / Service line**

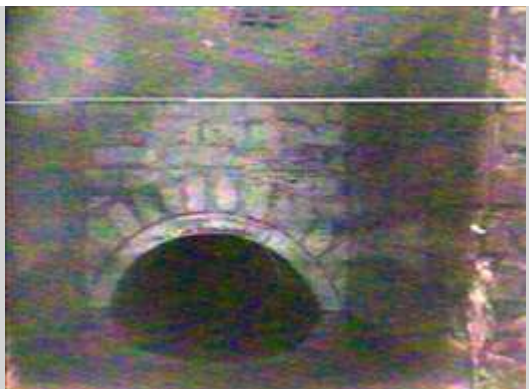
6 O'Clock Inflow

27 in. Circular Gravity Sewer

Pipe Material: **Clay** ☐ Pipe Lined

Invert Depth: **11.78** (ft.) Flow Characteristics: **Turbulent**

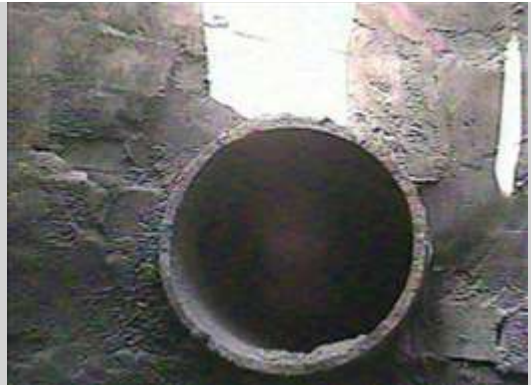
9 O'Clock Inflow

8 in. Circular Gravity Sewer

Pipe Material: **Clay** ☐ Pipe Lined

Invert Depth: **13.30** (ft.) Flow Characteristics: **Slow**

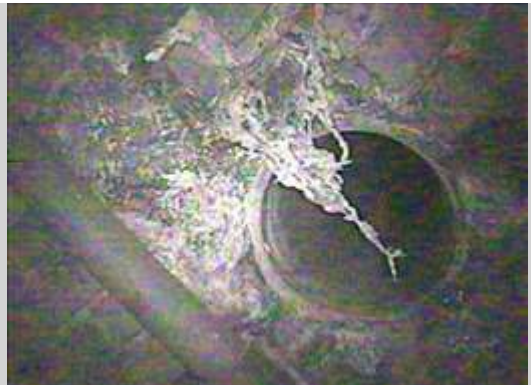
9 O'Clock Inflow

8 in. Circular Gravity Sewer

Drop In @ 9 O'Clock

Invert Depth: **10.90** (ft.) Flow Characteristics: **None**

Drop: **Outside Direct**

Inv Depth: **11.30** (ft.)

Drop Condition: **Open**
